SUBJECT: AFCEE ENRAC F41624-01-D-8545; Task Order 0071
MMR SPEIM/LTM/O&M Program
CDRL #A012
**Ashumet Pond Geochemical Barrier for Phosphorus Removal Installation
Summary Report**

Ashumet Pond Geochemical Barrier for Phosphorus Removal Installation Summary Report

March 2005

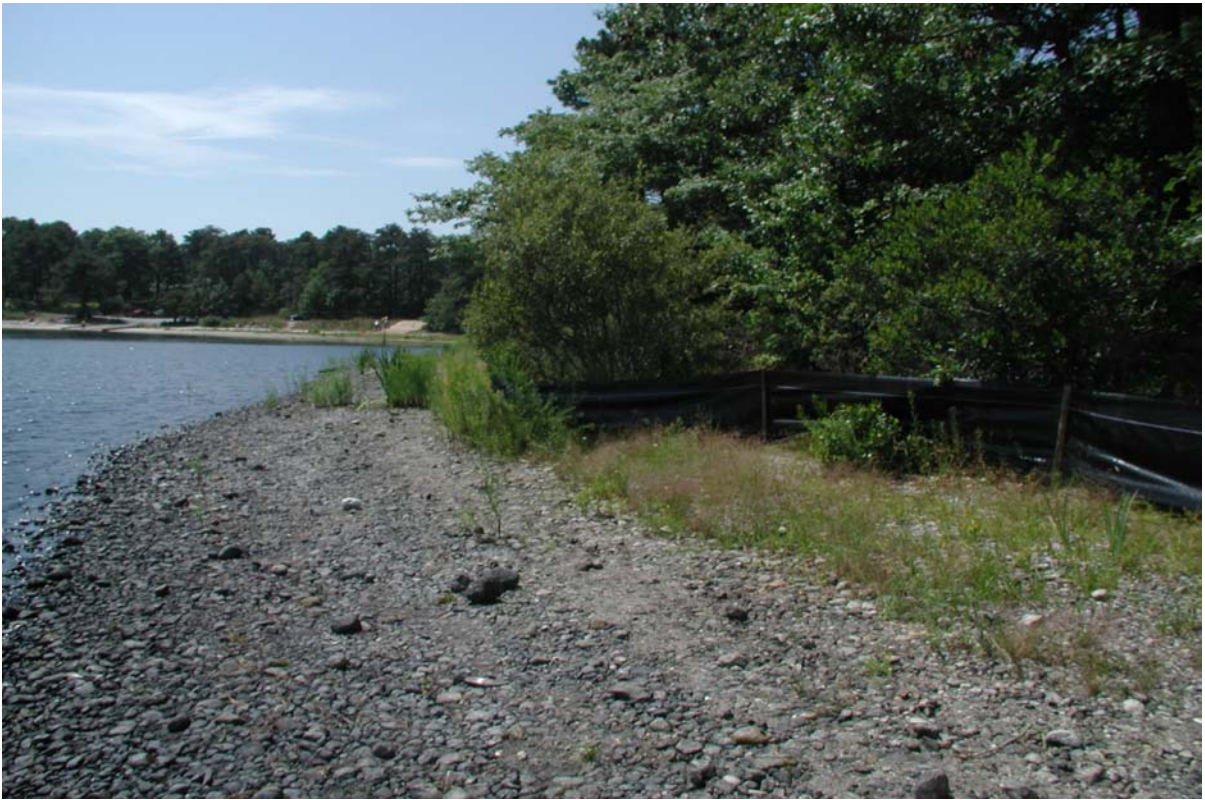
Picture 1

Shoreline of Ashumet Pond prior to barrier construction. (8/10/2004)

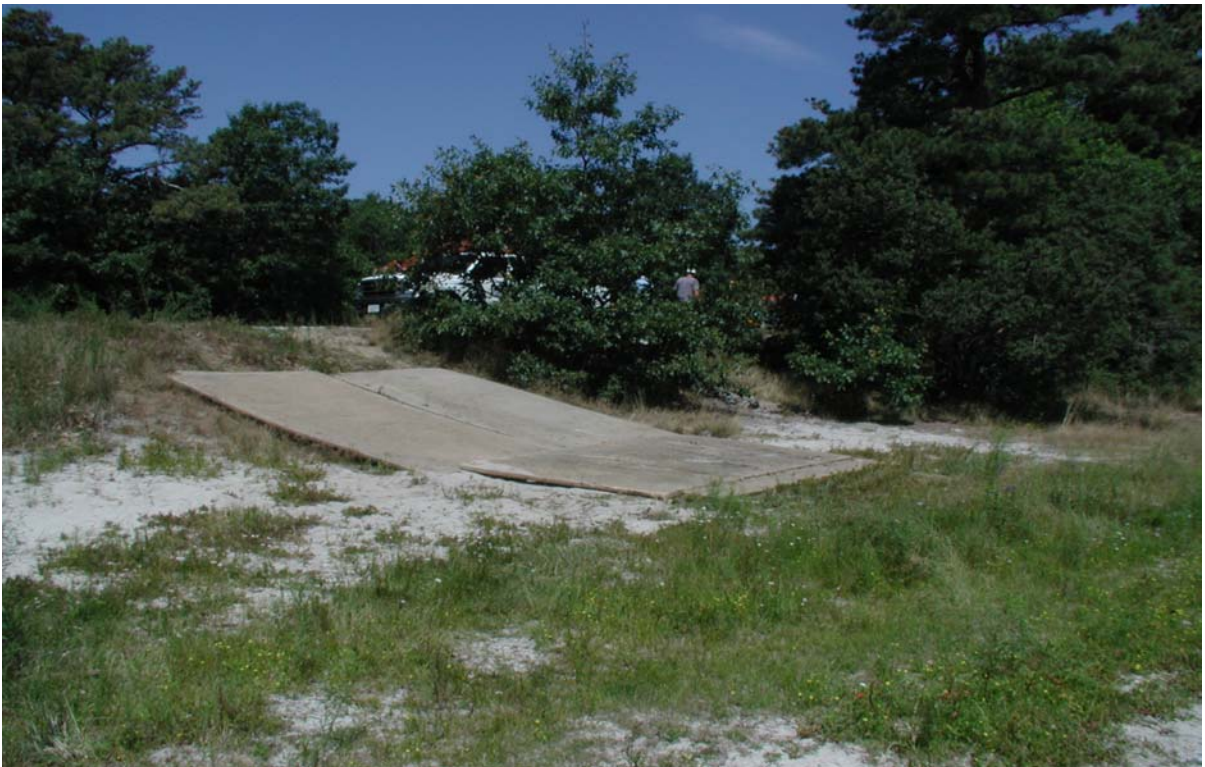
Picture 2

Initiation of construction of HDPE grid mat system, Fisherman's Cove. (8/10/2004)

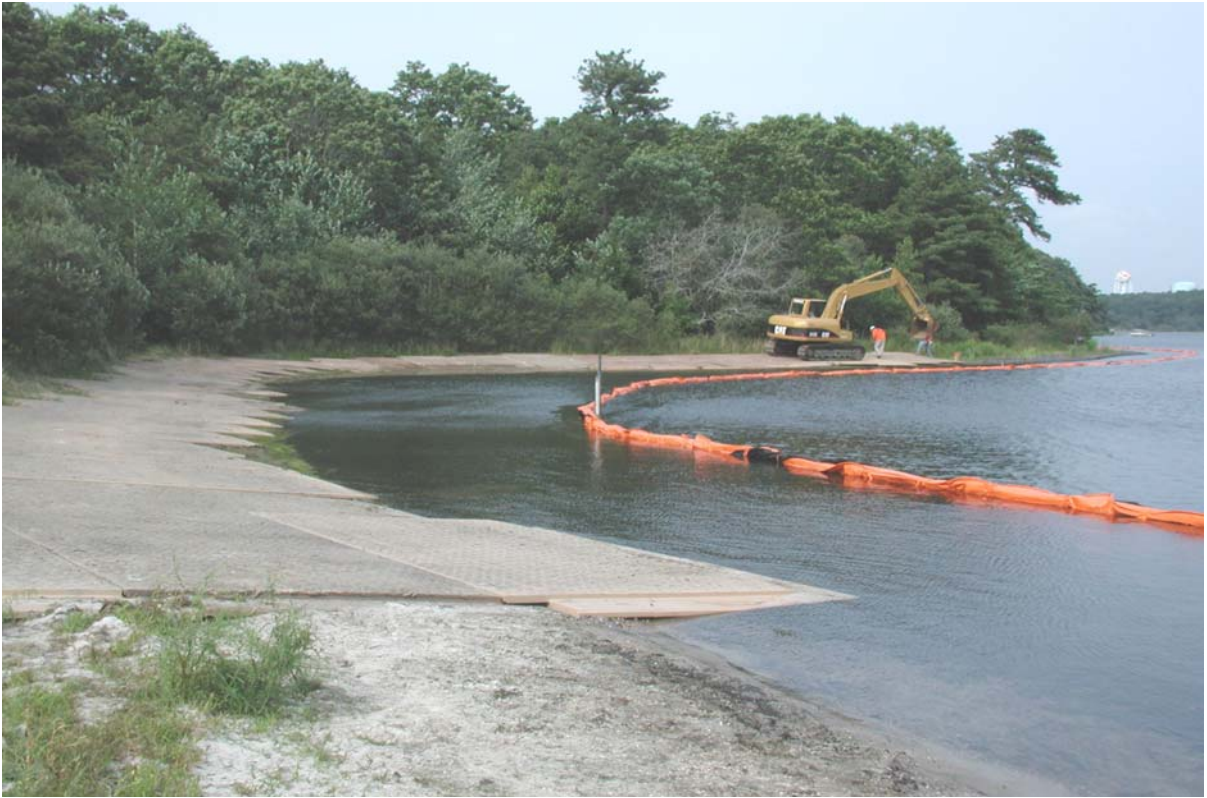
Picture 3

Construction of HDPE grid mat system with containment boom offshore. (8/11/2004)

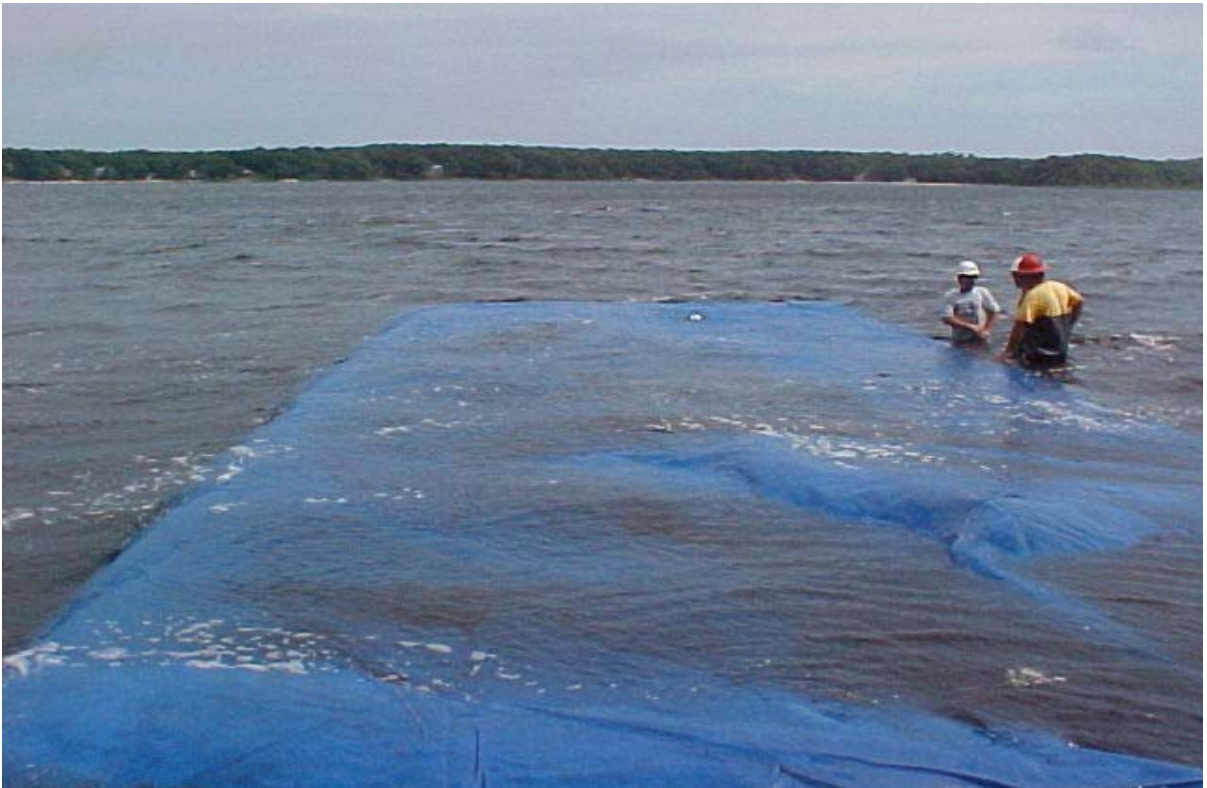
Picture 4

Positioning of bladder cofferdam. 8/12/2004)

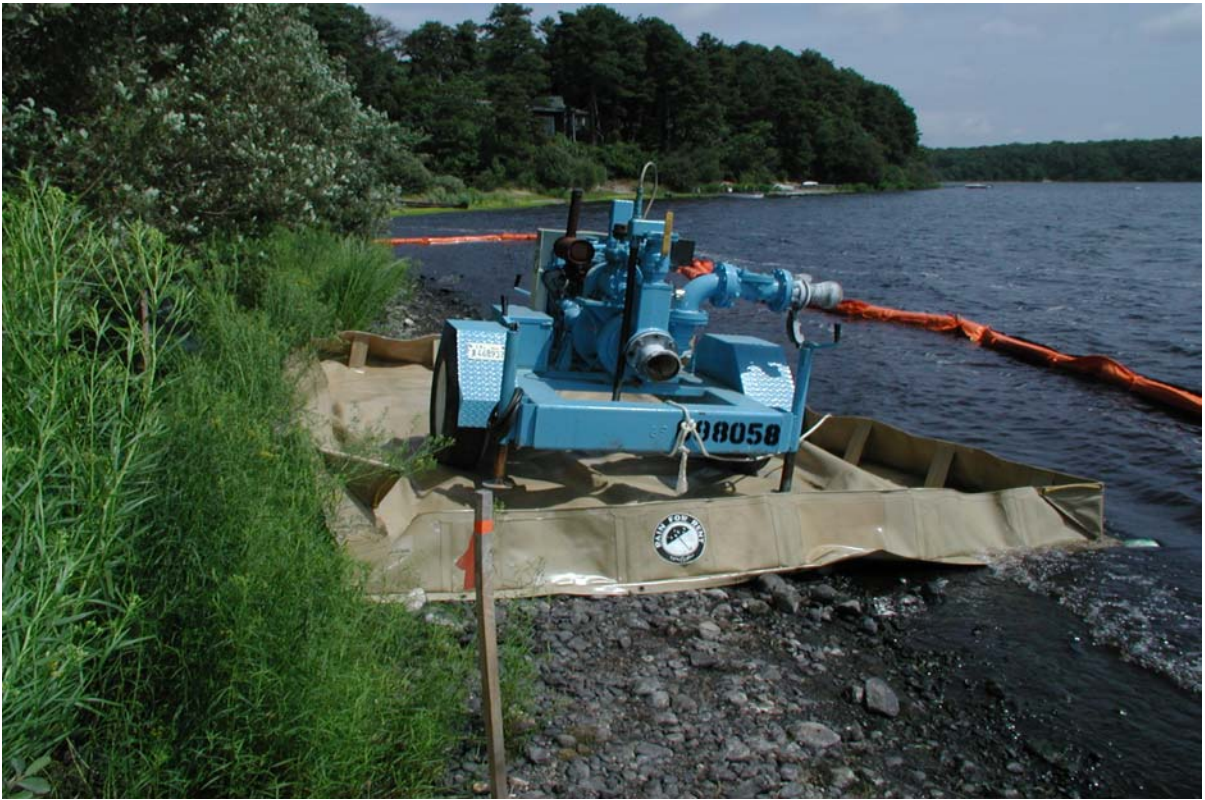
Picture 5

Pump placement with portable secondary containment and boom/silt curtain off shore.
(8/12/2004)

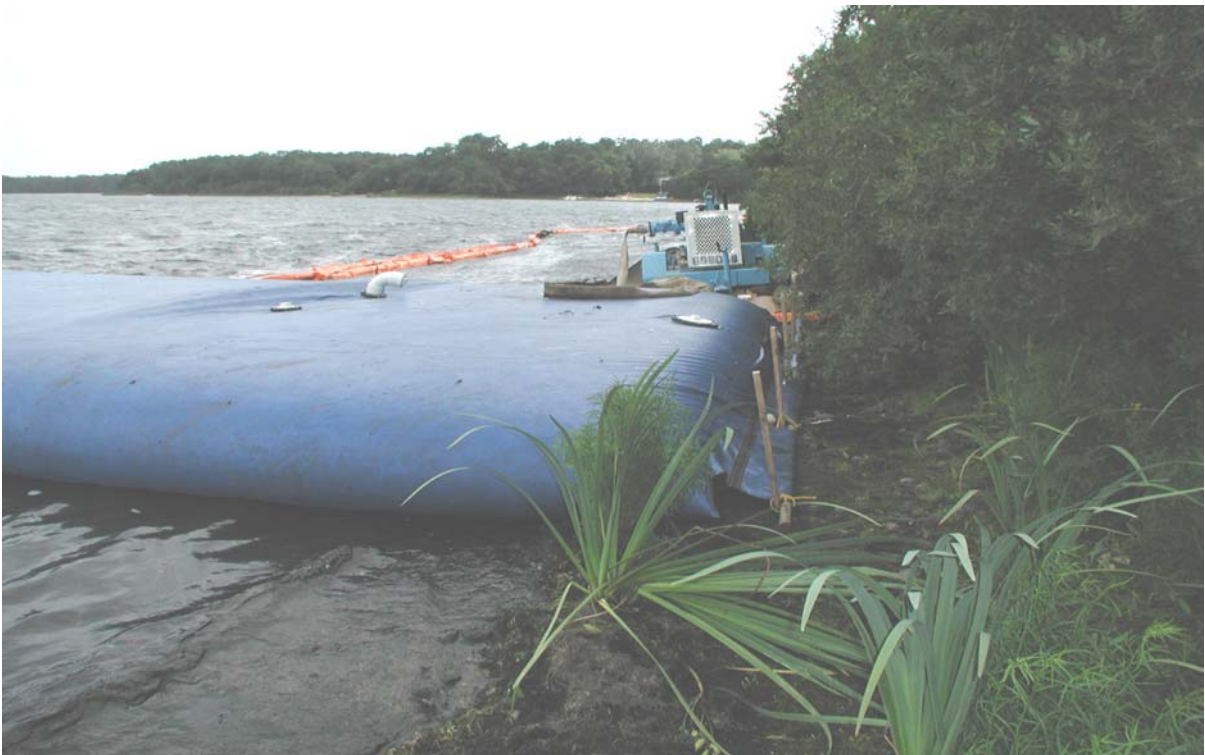
Picture 6

Initial bladder cofferdam filling on north side of construction zone. (8/17/2004)

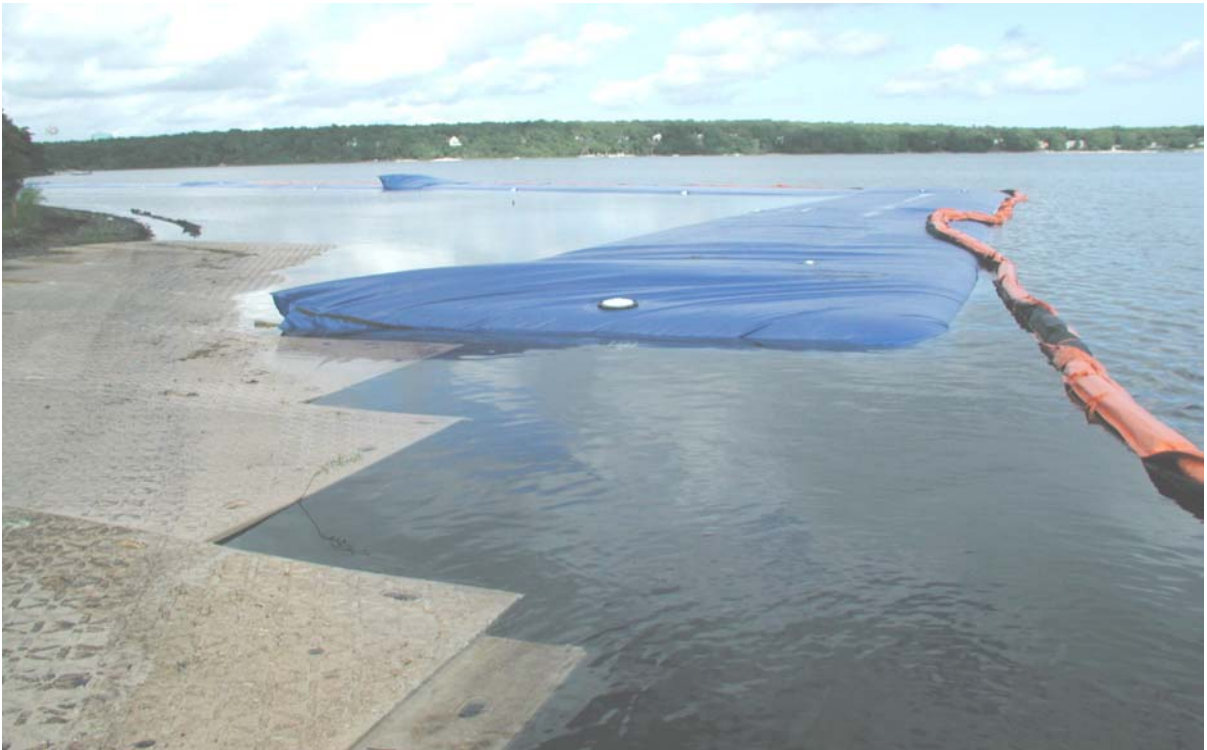
Picture 7

Bladder cofferdam placement initial filling on south end of construction zone. (8/17/2004)

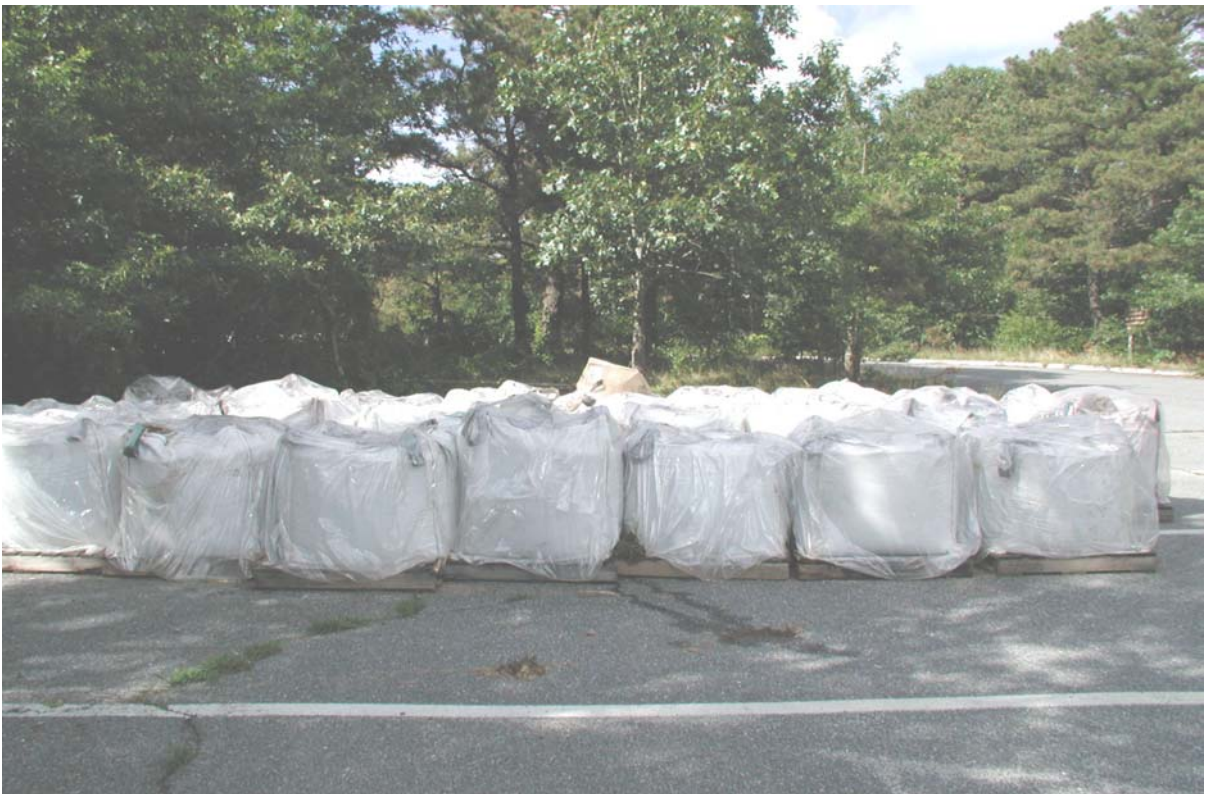
Picture 8

Super sacks of ZVI staged in Boat Ramp parking area. (8/17/2004)

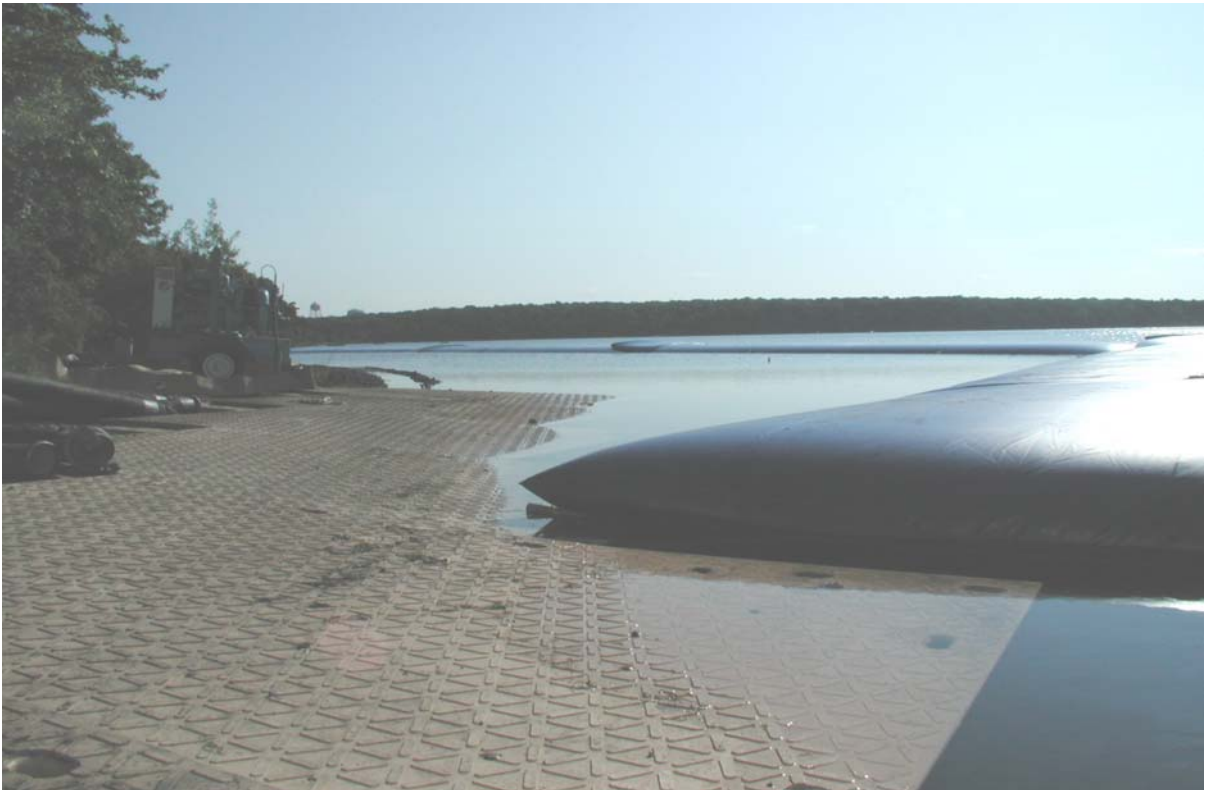
Picture 10

Completion of filling of bladder cofferdam structure. (8/18/2004)

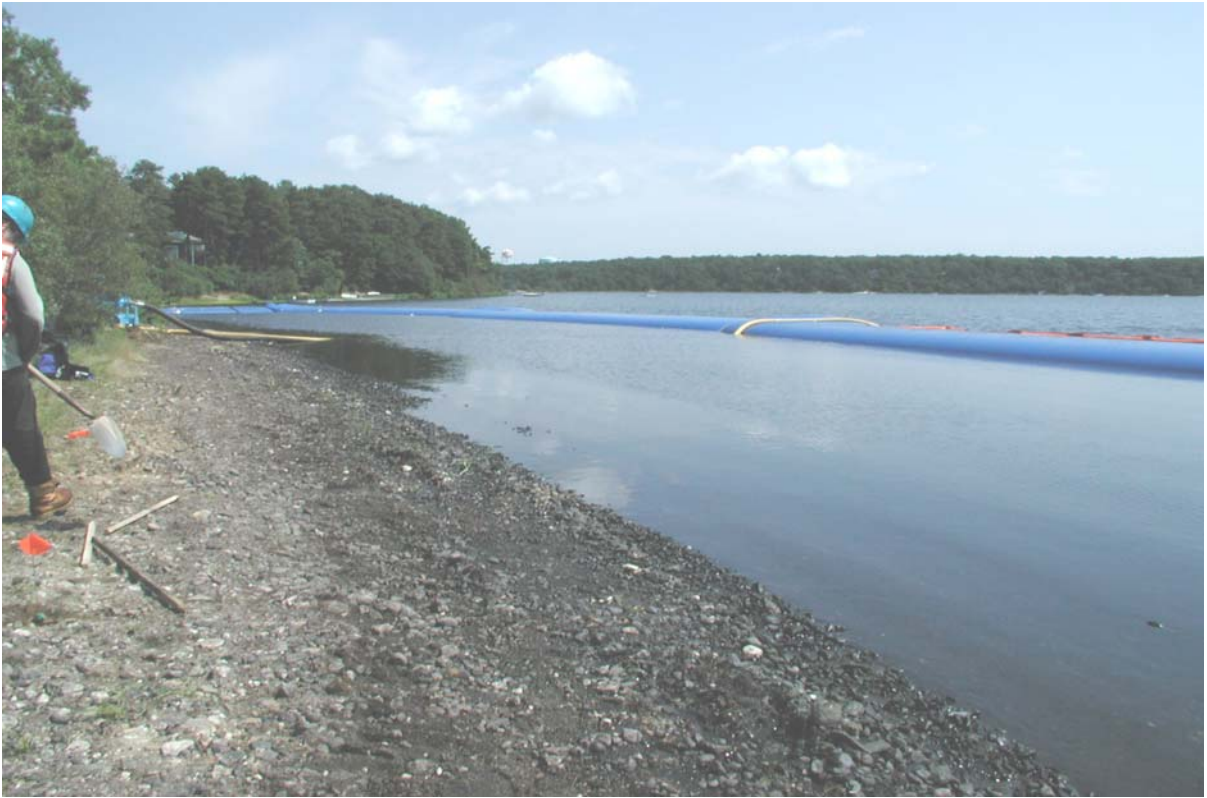
Picture 11

Initial dewatering underway within cofferdam. (8/18/2004)

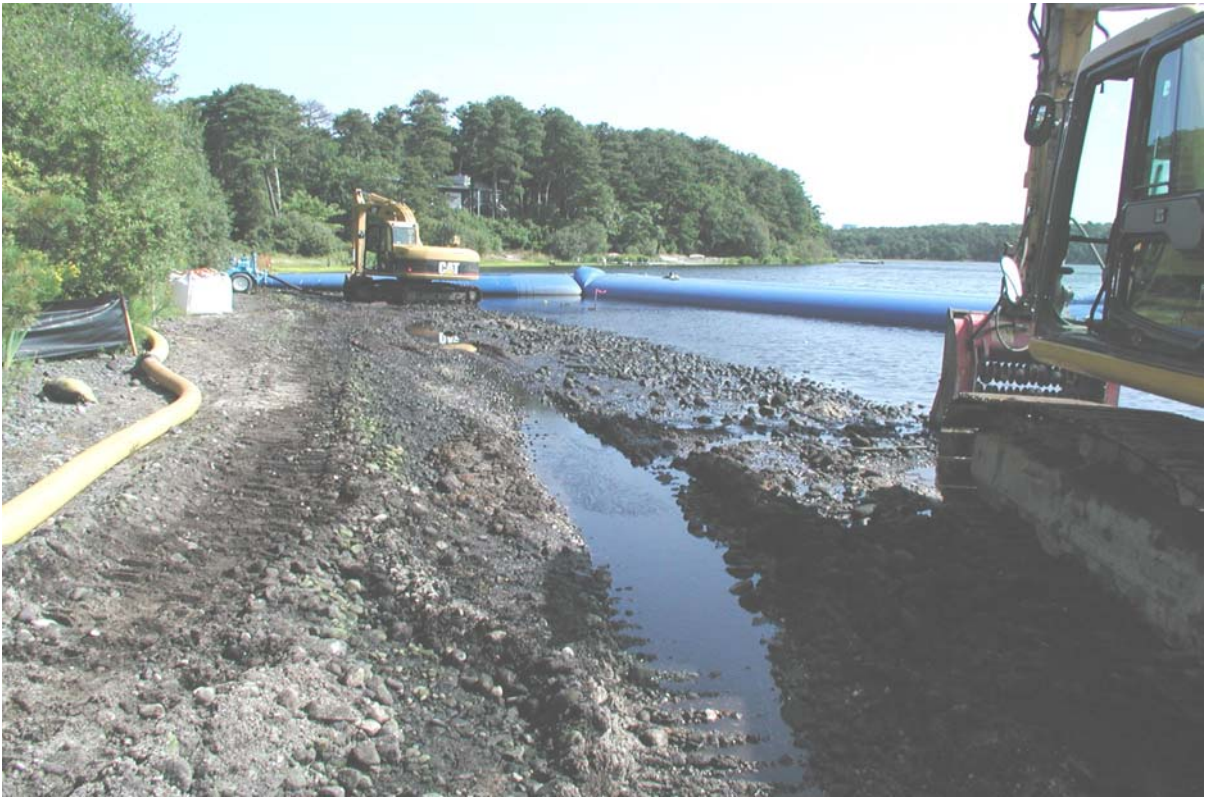
Picture 15

Initiation of excavation work, north end of barrier area. Dewatering underway. (8/24/2004)

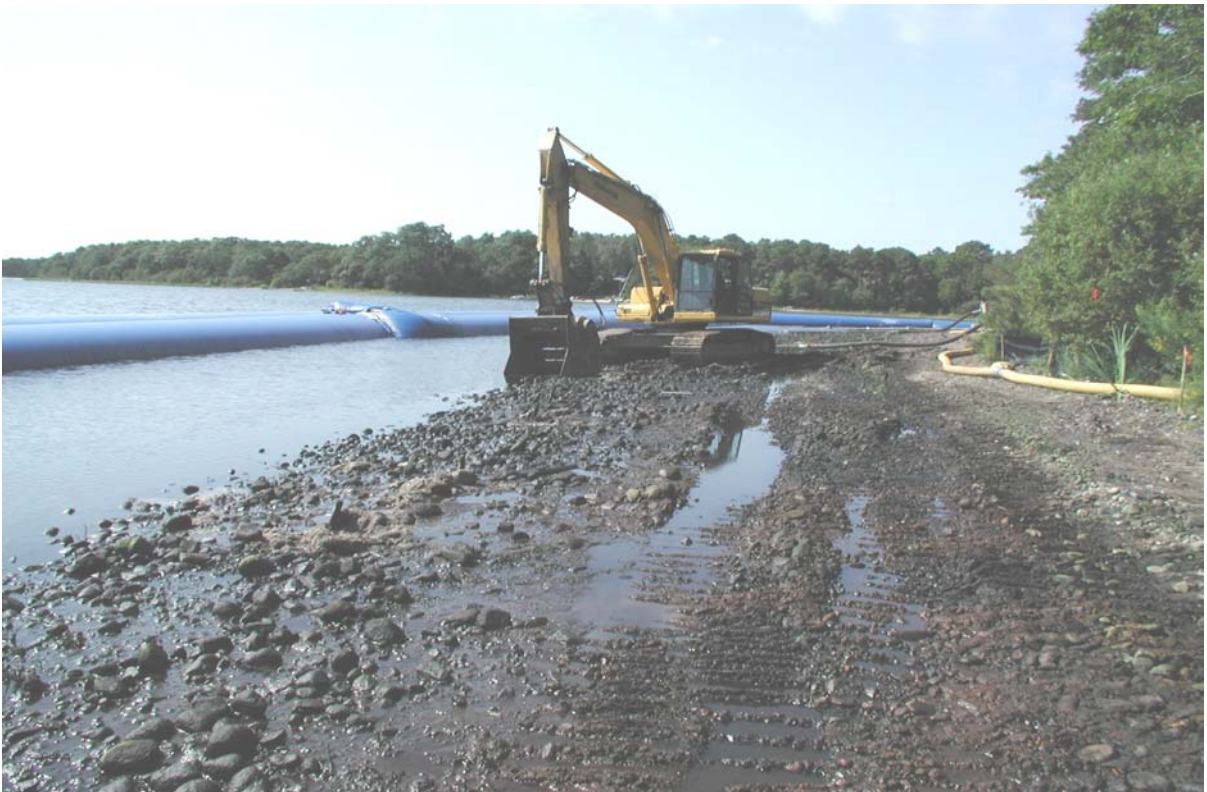
Picture 16

Dewatering underway with three pumps operating. (8/24/2004)

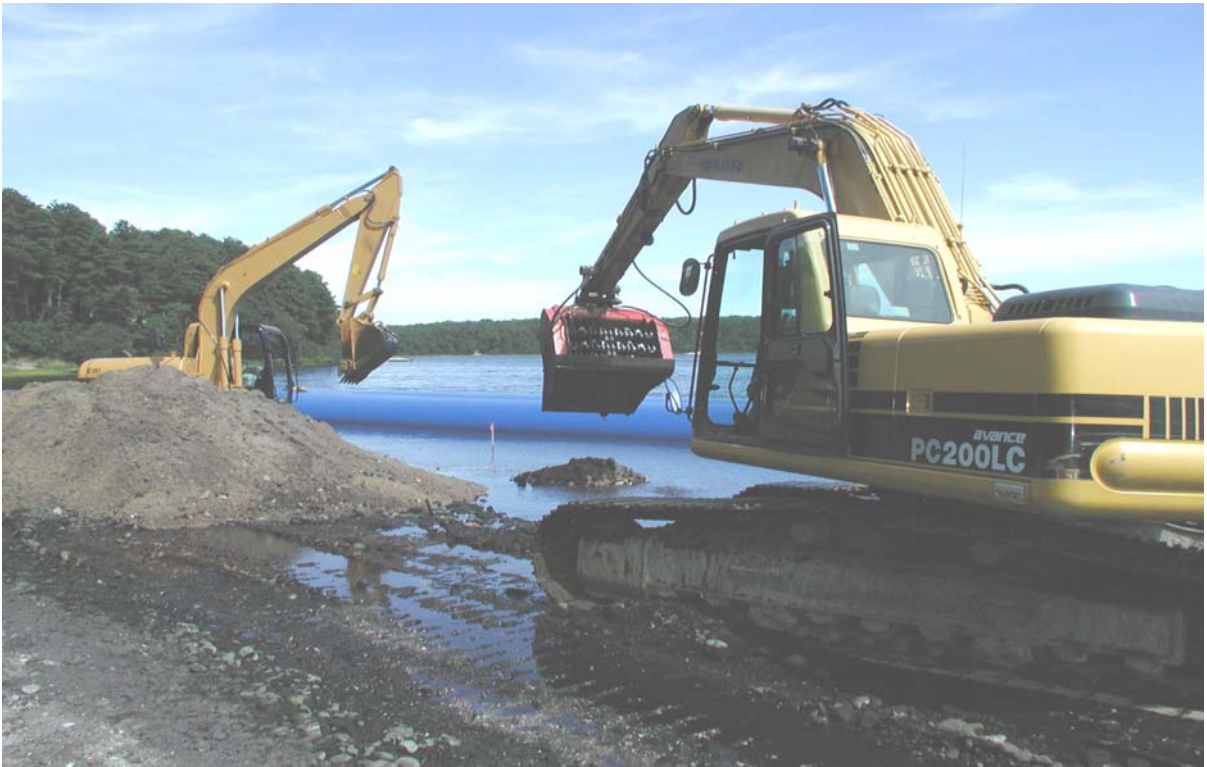
Picture 18

Initial excavation and sediment screening. (8/24/2004)

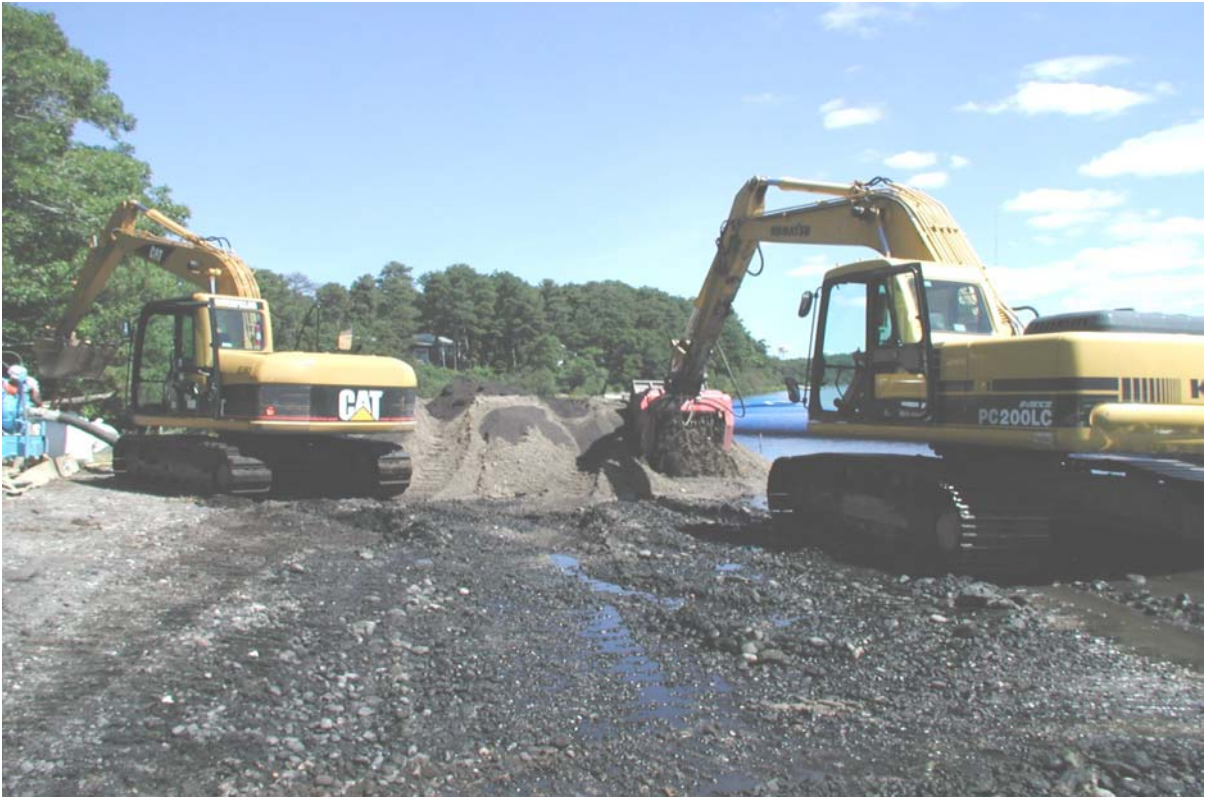
Picture 23

ZVI mixing in excavated sediments. (8/25/2004)

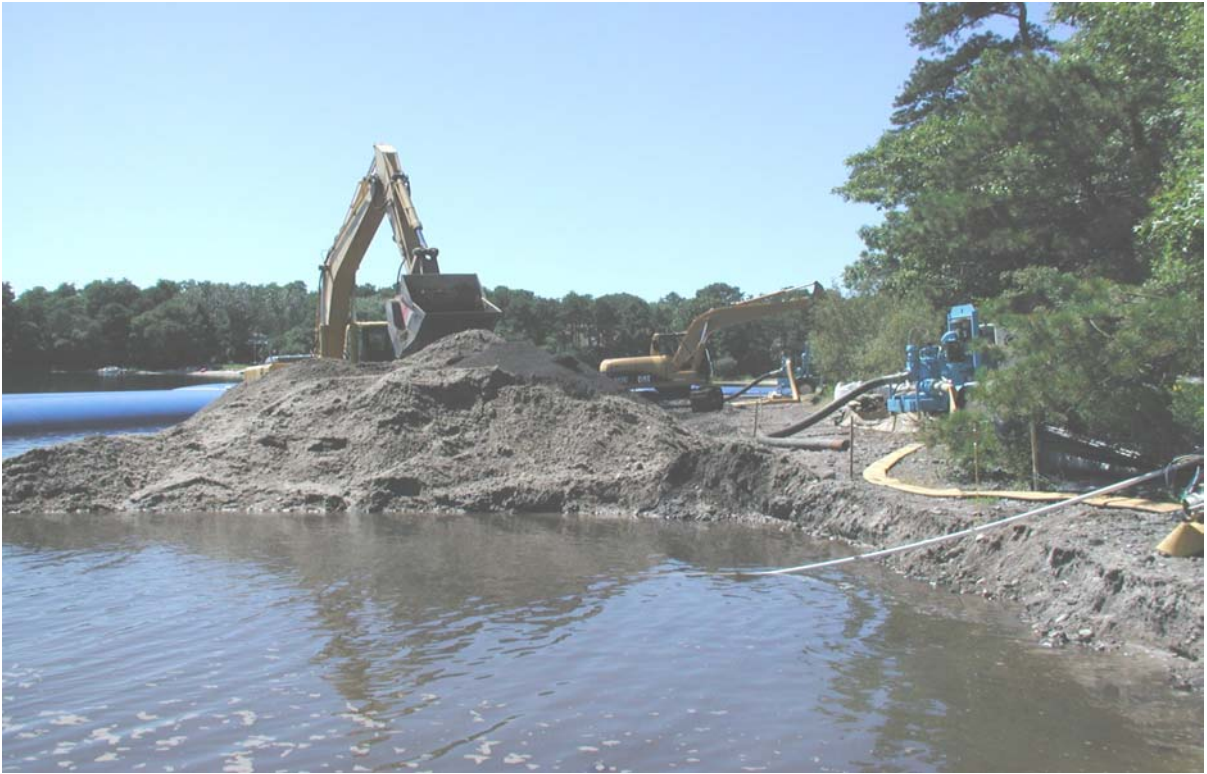
Picture 25

Excavation awaiting backfilling. Note pond water in-fill. (8/25/2004)

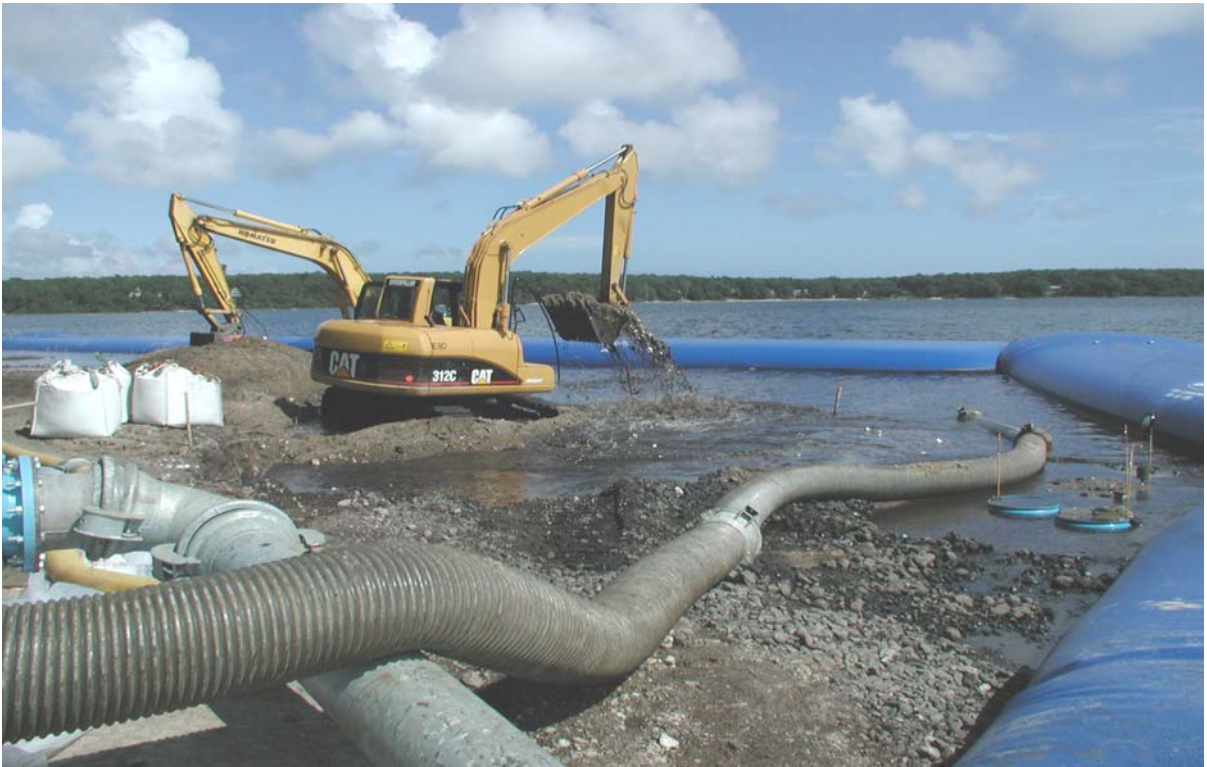
Picture 34

Excavation/mixing of sediments at south end of barrier area. (8/30/2004)

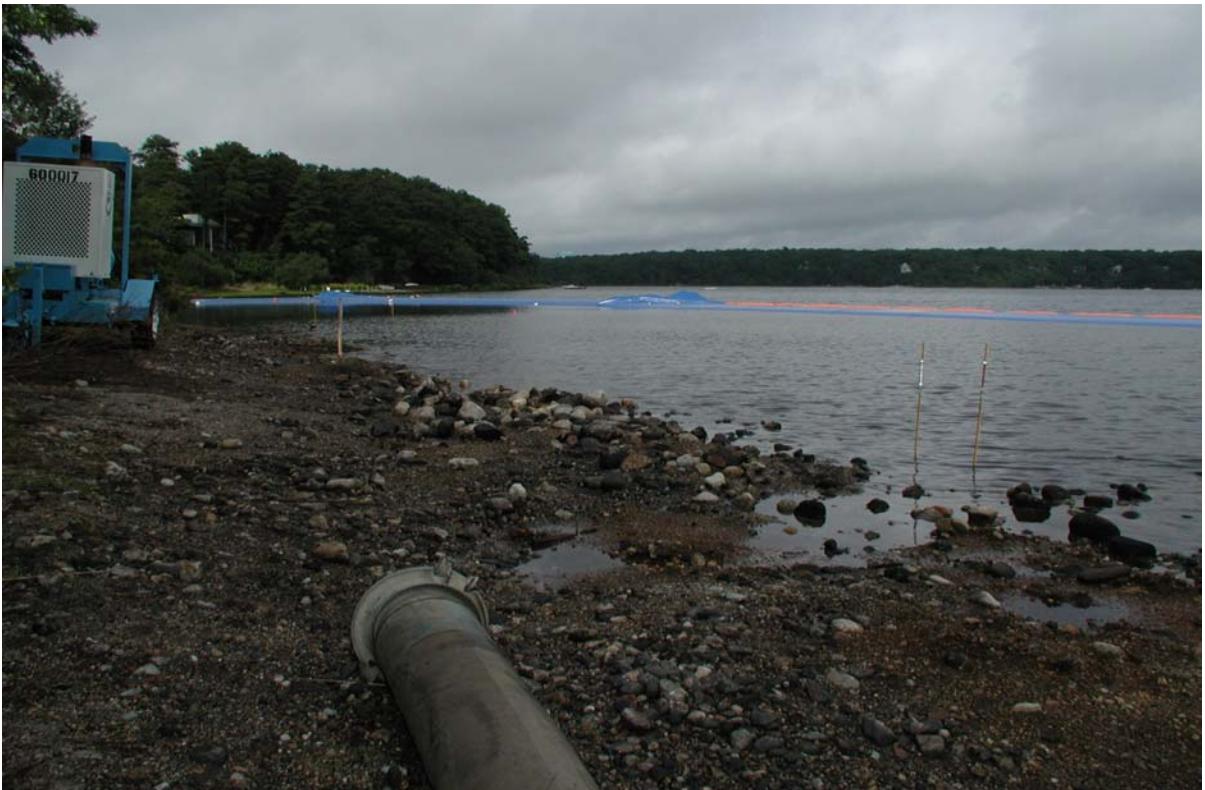
Picture 36

Bladder cofferdam pumping (deflation) underway. (8/31/2004)

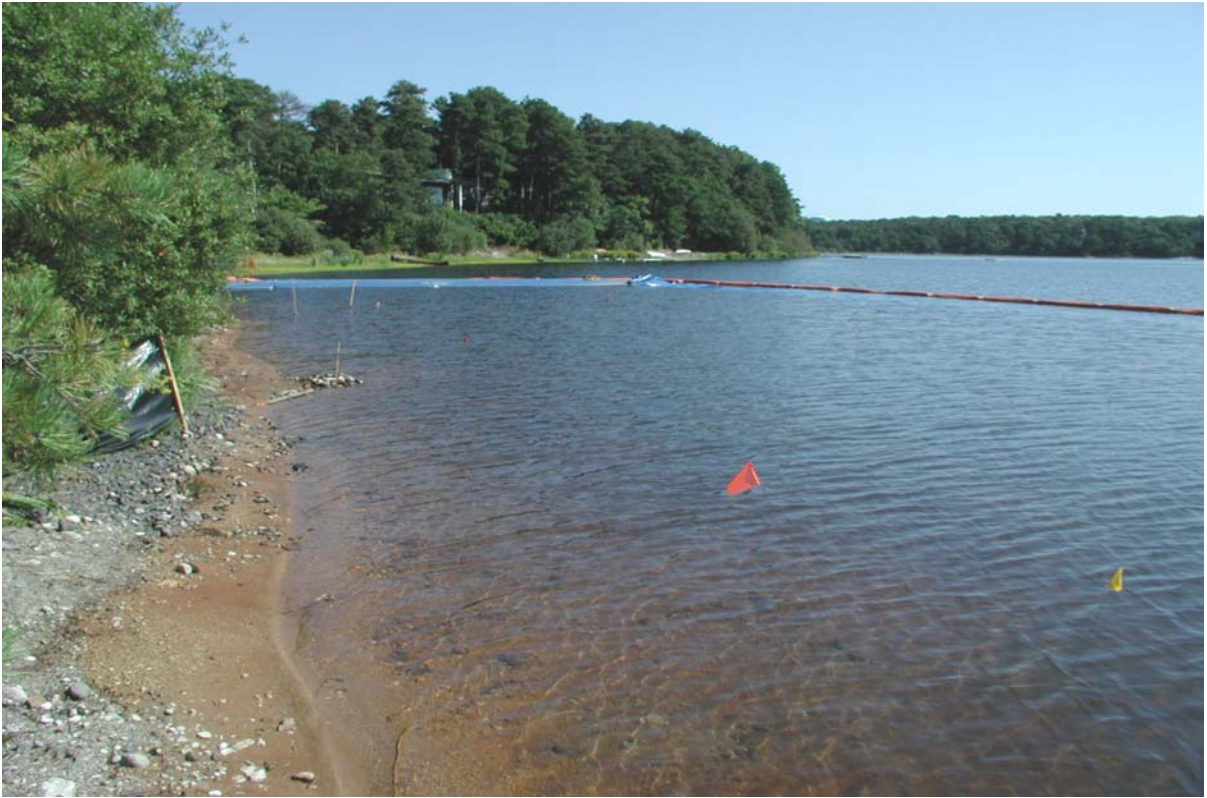
Picture 39

Geochemical barrier area under restored pond stage. (9/07/2004)

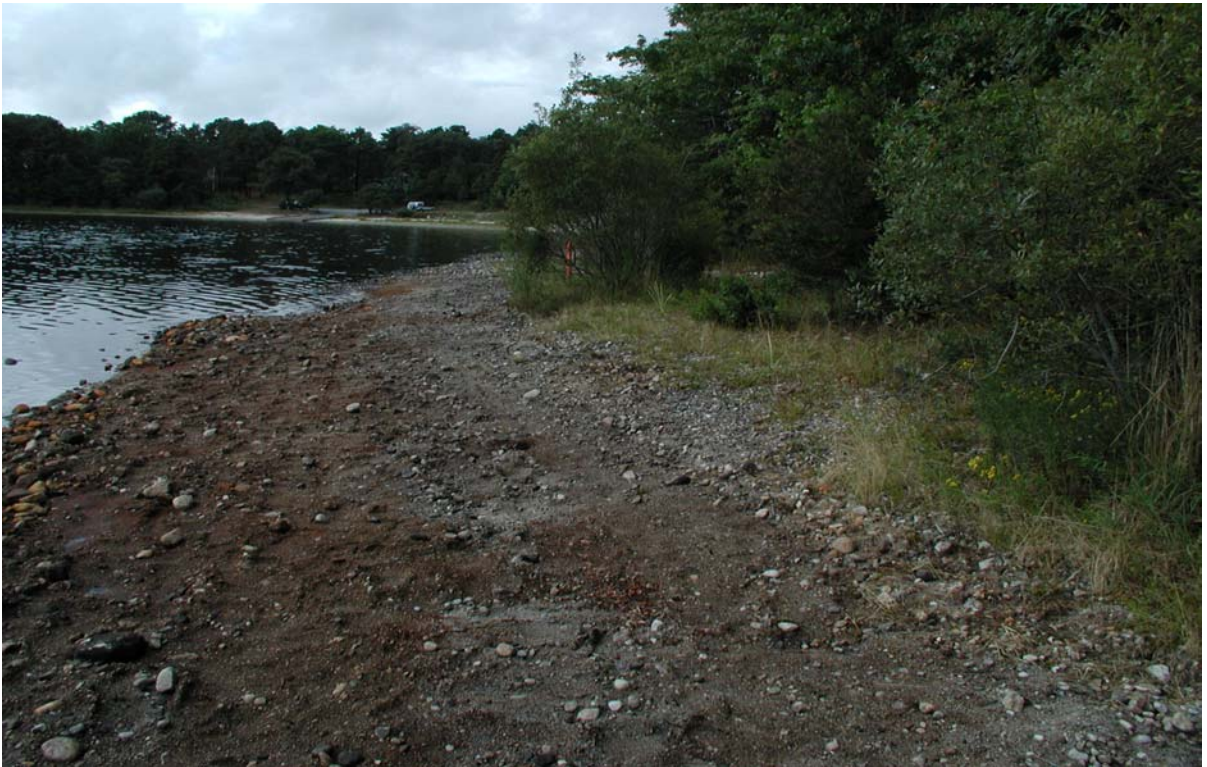
Picture 40

Shoreline of Ashumet Pond following barrier construction. (9/16/2004)

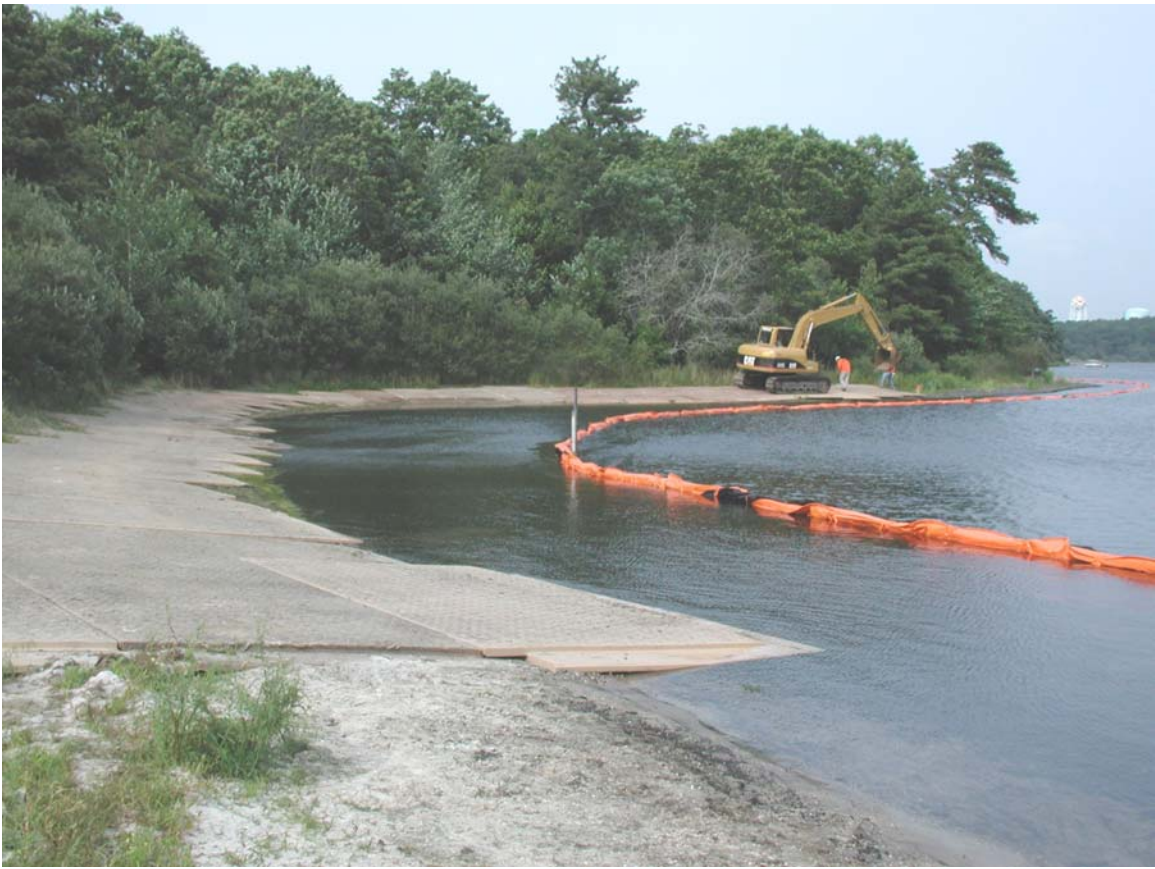
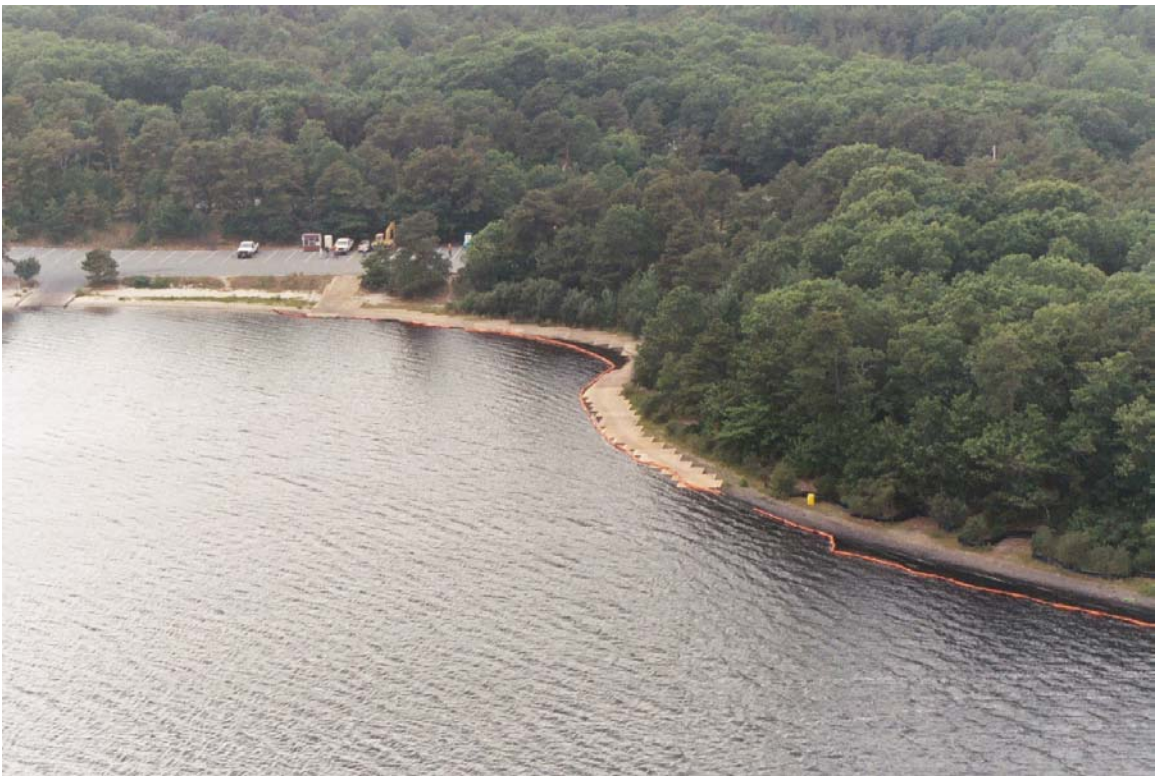
FIGURE 9
HDPE Grid/Mat System Installation

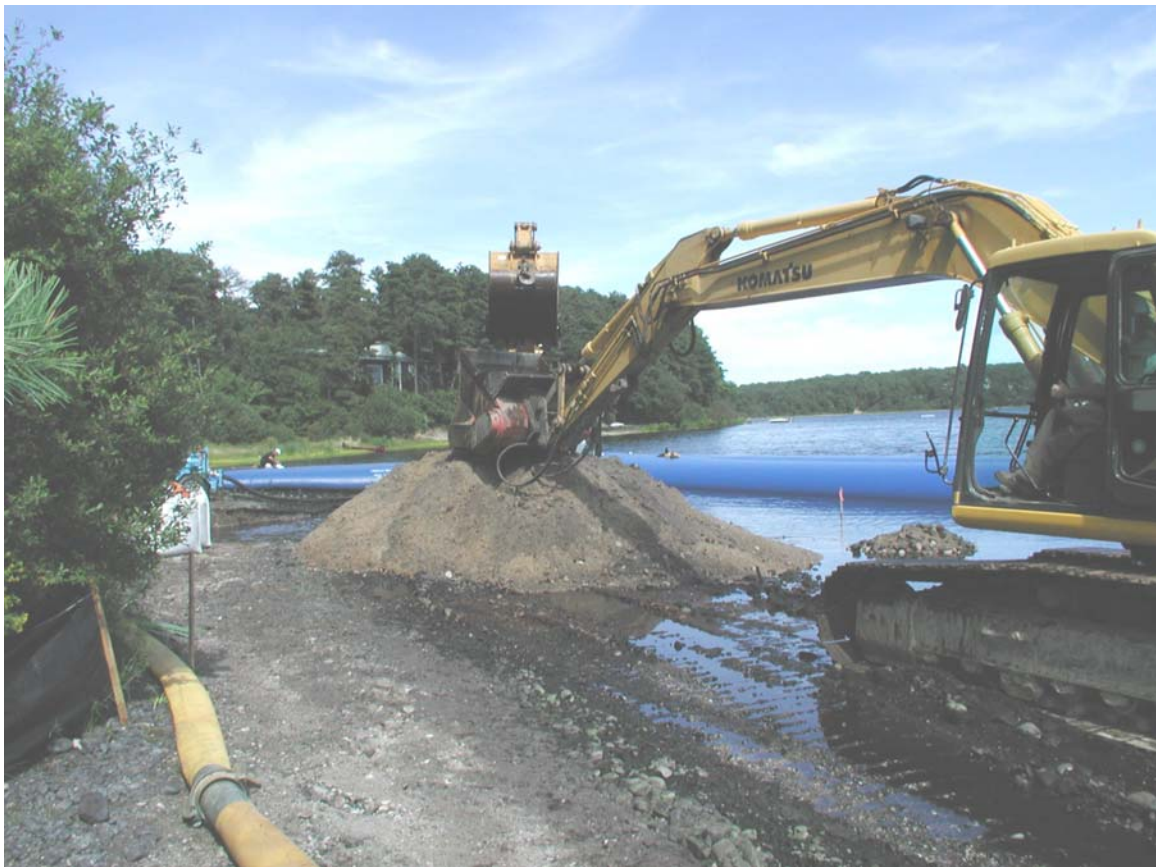
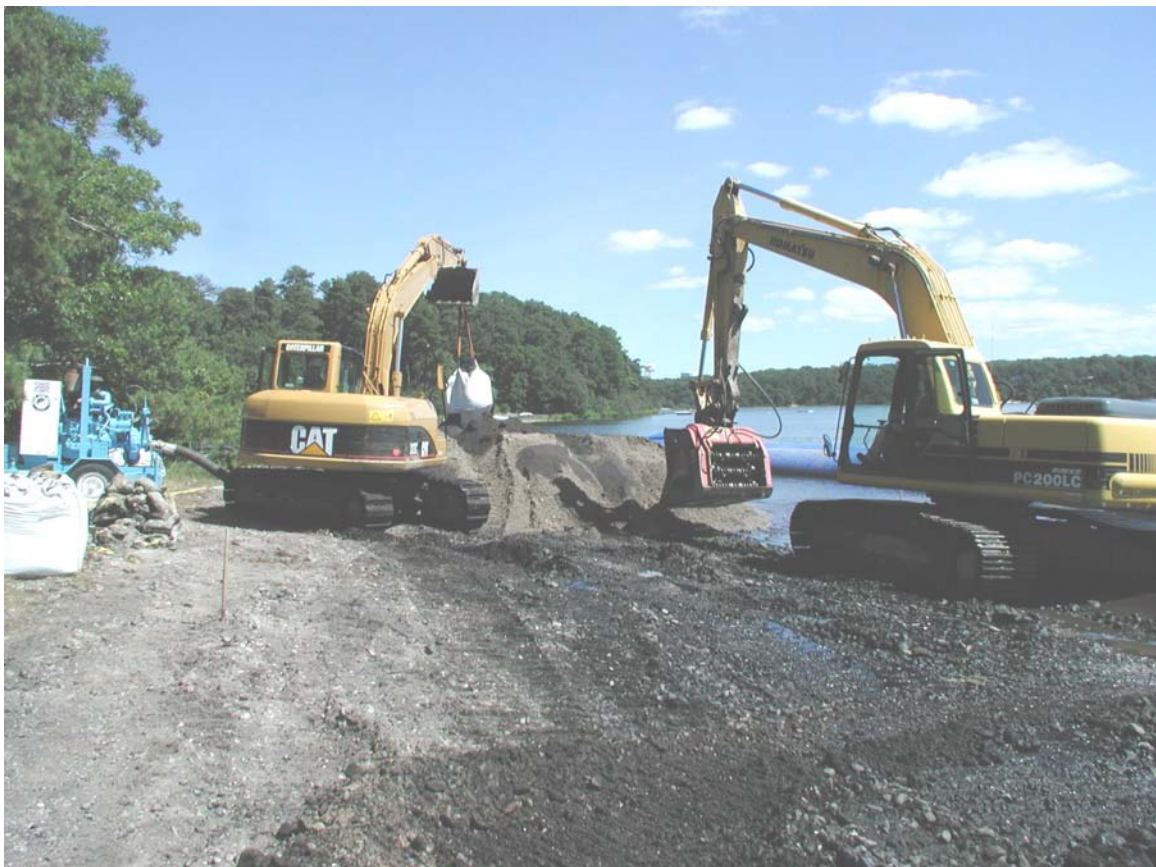
FIGURE 11
Excavation and Mixing Activities
